**RESEARCH REPORT REGARDING  
THE CANYON AT MANRESA UPLANDS**

**REPORT PREPARED BY  
SAND DOLLAR BEACH HOMEOWNERS ASSOCIATION**

**Date: October 19, 2006**

## THIS REPORT IS PREPARED FOR THE CALIFORNIA DEPARTMENT OF PARKS AND RECREATION, SANTA CRUZ DISTRICT BY THE SAND DOLLAR BEACH HOMEOWNERS ASSOCIATION

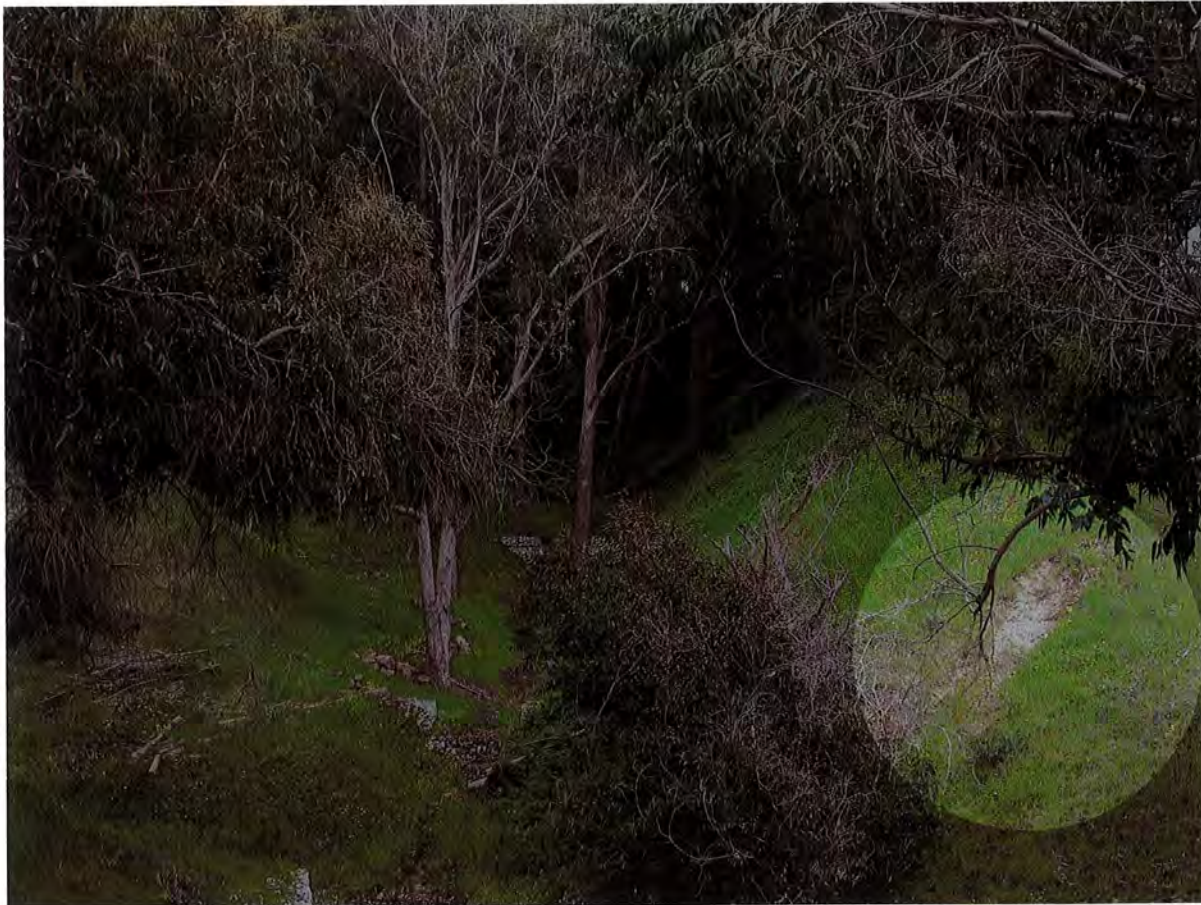
*Early Stages of Erosion*

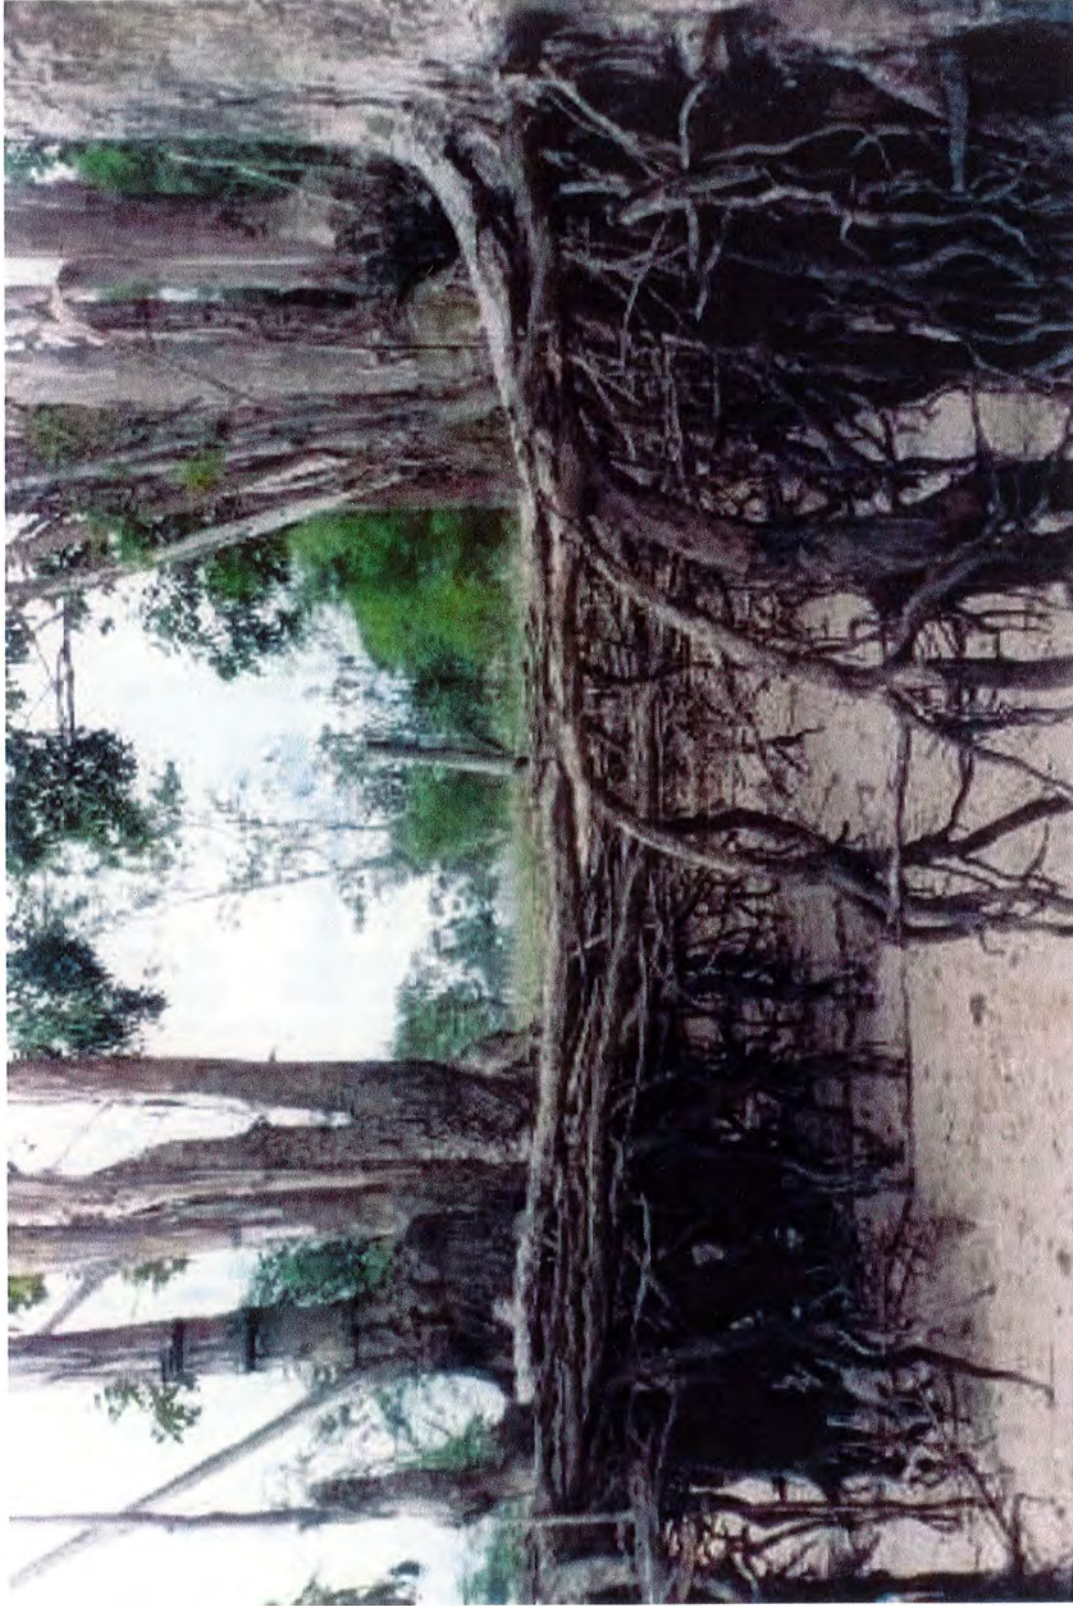
***Exhibit 4***

***Eucalyptus Globulus Root System***

Eucalyptus trees are somewhat shallow rooted with the exception of one larger tap root. Their surface root system can spread 40-50 feet from the trunk. They are considered trees that can take up a lot of water out of the soil which can be a good thing on slopes with excessive subsurface moisture conditions.

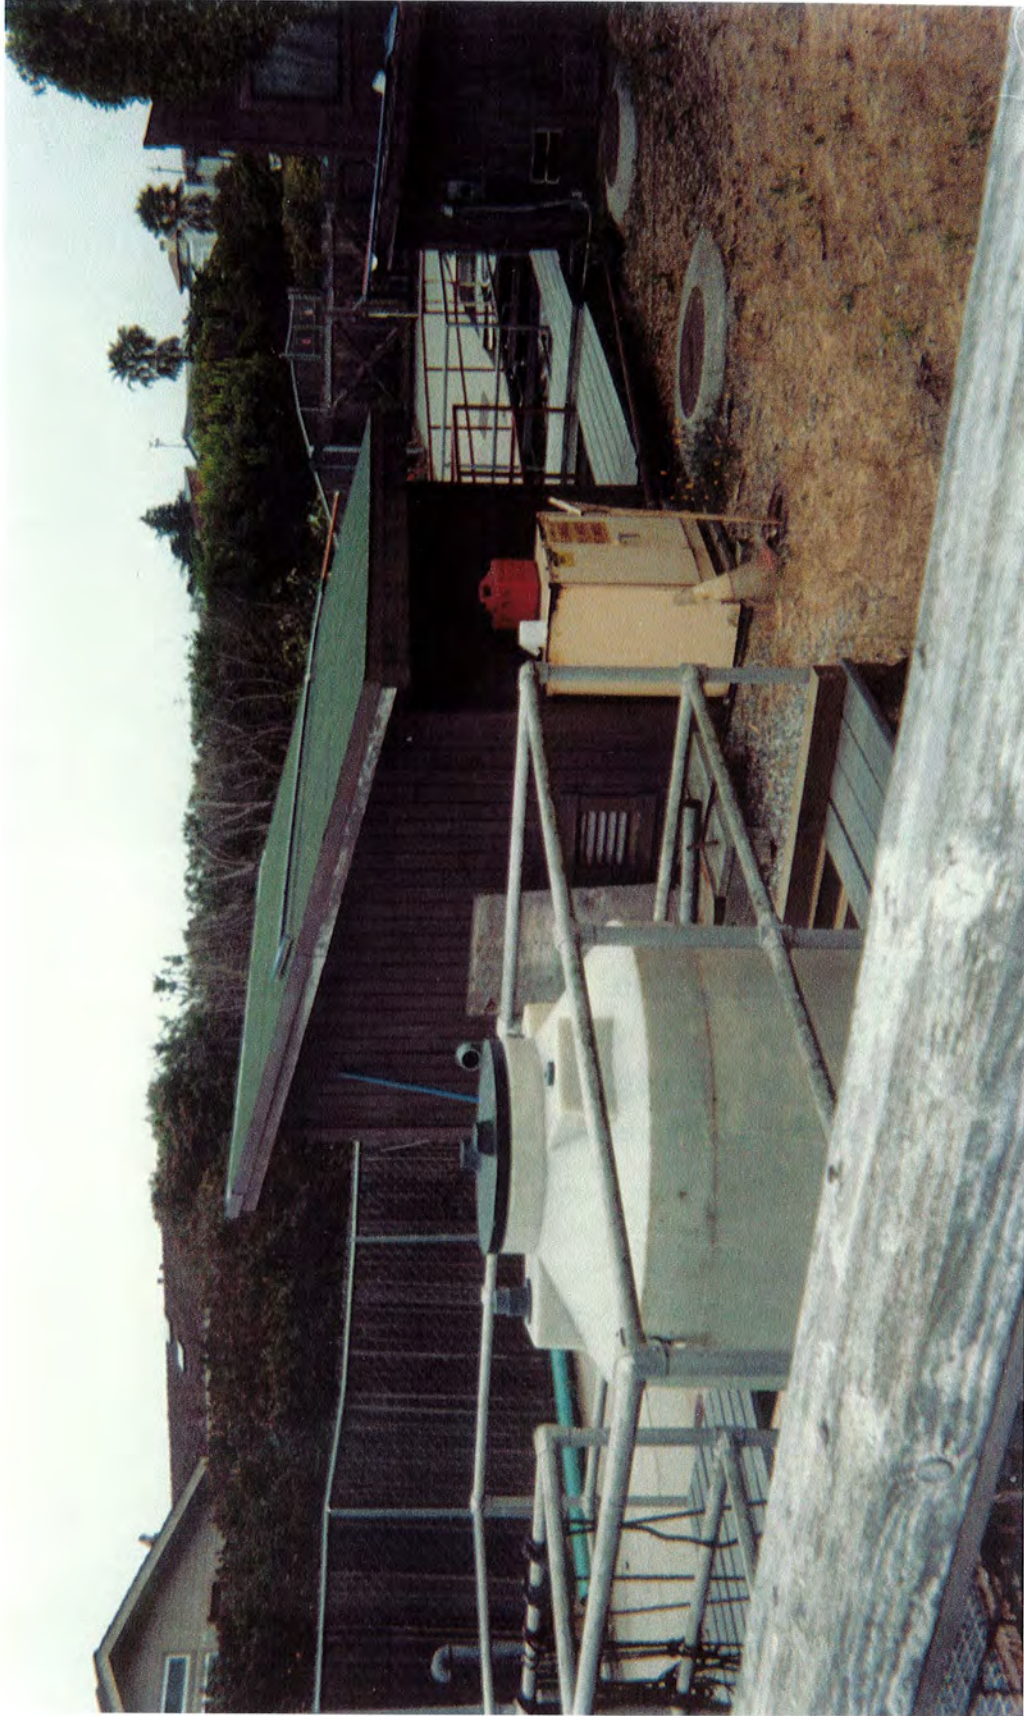
**Canon Del Sol - Sewage Treatment Plant**  
**Exhibit 5**

Sand Dollar Beach's plant is uphill from the Canon Del Sol plant (Exhibit 5 and Exhibit 6). The caisson pits are up from the plant. The sewage reaches the plant via two pump houses and this line is at the rim of the arroyo/canyon.

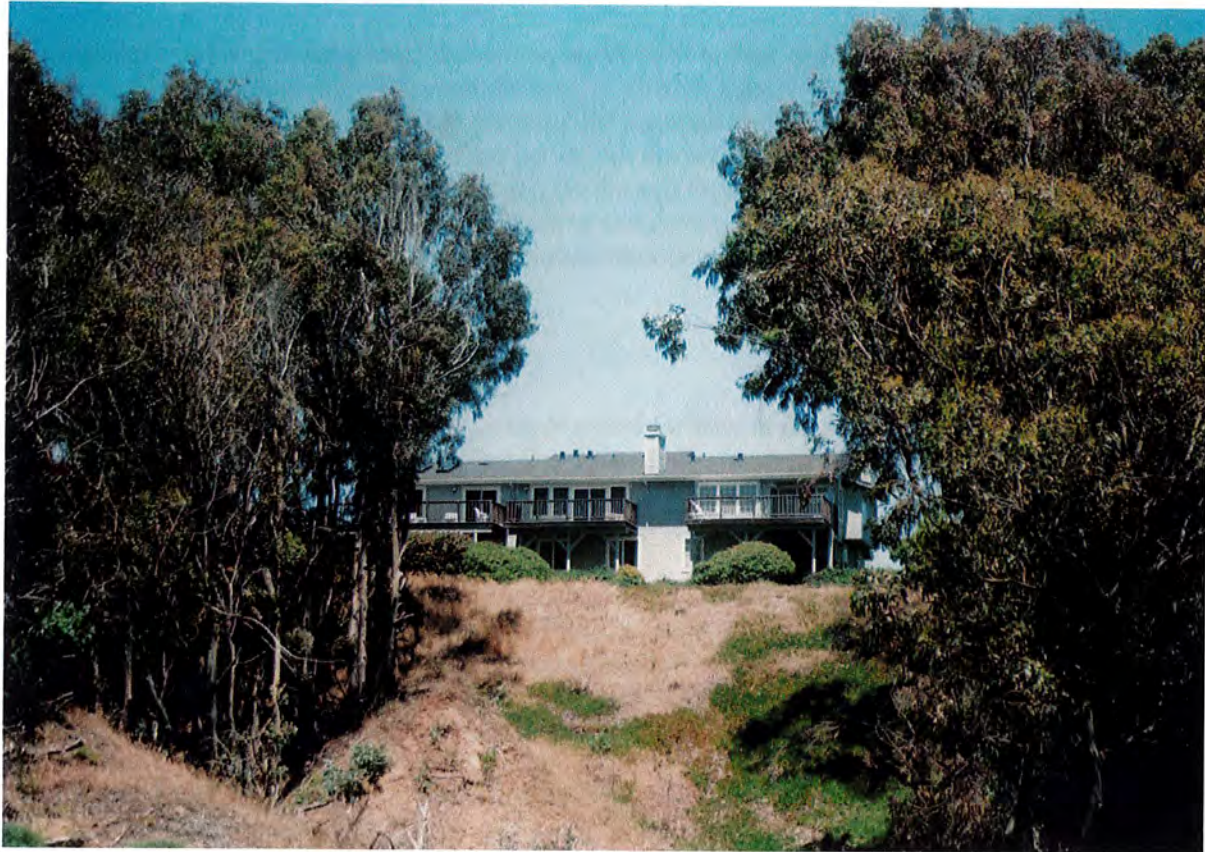
*Exhibit 6*

**Current tree view for day use visitors**

**Removal of trees on the right will open the view to  
Canon Del Sol's sewer plant**
